# Lisle Library District

## Facility Condition Assessment Report

July 10, 2019

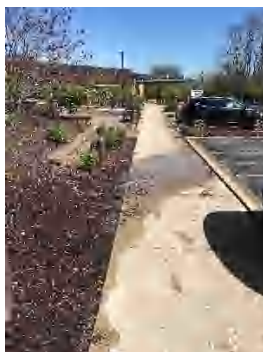
Landscape mulch bed on west side of southeast parking lot: During winter snow melt times and heavy spring rains, this sloped mulch bed seeps water across the sidewalk and into the parking lot. This was noted as an erosion concern and a safety concern during freeze/thaw cycles.

Landscape mulch bed on west side of north parking lot adjacent to Receiving Door: During winter snow melt times and heavy spring rains, this sloped mulch bed seeps water down the hill into the north parking lot and across the staff entry drive aisle. This was noted as an erosion concern and a safety concern during freeze/thaw cycles.

- Include all site drainage and stormwater issues as part of further investigation as presented in the Appendix. Improve drainage of landscape beds by updating or replacing drain tile system and installing a French drain assembly. **Priority - Critical**
- Perform maintenance to masonry planters and retaining walls that are in Fair condition and exhibiting signs of movement. **Priority - B**

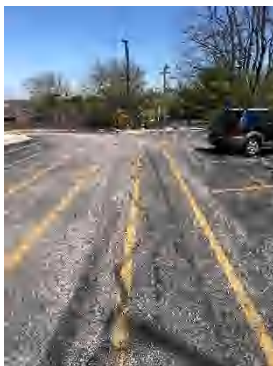
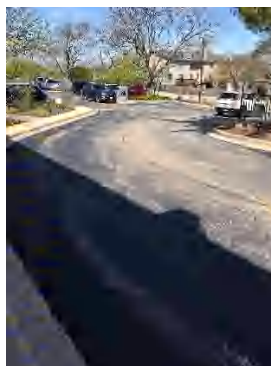
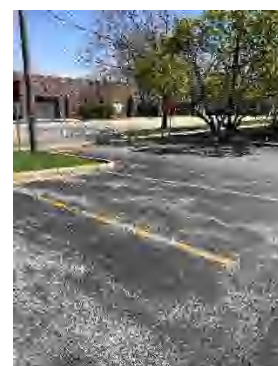
The parking lot is generally in good to fair condition. There are signs of age, including cracking of the surface layer and settlement in some isolated areas around tire spots in stalls and adjacent to storm structures in the parking lot. It appears that sealcoating and striping maintenance occurs periodically, having recently been recoated. With continued treatment of cracks and annual sealcoating, the parking lot will provide up to ten years of service.

- Perform annual maintenance and sealcoating/striping of parking lot. **Priority - A**
- Repair cracked broken curbs. Budget for spot repairs of settled areas for short-term (0-2 year) repair. **Priority - Critical.**
- Budget for repaving entire lot in ten years. **Priority - C.**

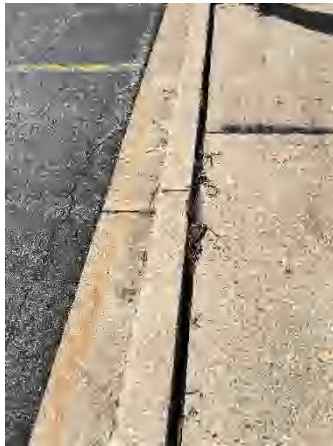
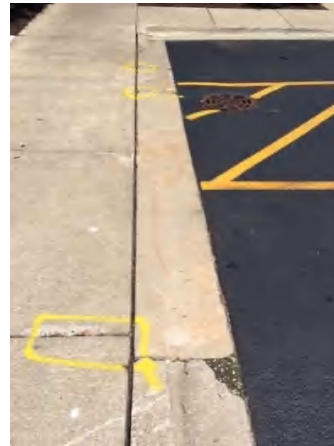
An area of concern with the sidewalk network is the type of original construction as it relates to the parking lot curbs. The concern is that the sidewalks and curbs are settling at different rates and separating from each other, in some instances by an inch or more. This condition creates a tripping hazard and the potential for a pedestrian's shoe to get stuck in the separation gap. The curbs and sidewalks were apparently poured as two separate pieces of concrete. When this occurs, rebar reinforcing is sometimes installed to connect the sidewalks and the curbs, although this type of installation is subject to cracking and other problems. No rebar was observed in the gaps. In more modern construction standards, sidewalk/curb installations are typically poured as an integral installation, with the curb and sidewalk as a monolithic unit. This installation type provides for a more integrated construction and was adopted as a direct result of the type of issues the Lisle Library sidewalk/curb installation is experiencing. Integral sidewalk curbs, due to their monolithic construction tend to settle more consistently and avoid the separation issue being experienced.

- The Library has been diligent about replacing broken or deteriorated sidewalks. This maintenance practice, as it relates to areas of concern both for curbs and sidewalks, is recommended to continue. **Priority – A for sidewalks as needed, Critical for curb deterioration.**
- Long term (10+ years), the sidewalks could be replaced with integral curb and sidewalk installations as part of a wholesale parking lot replacement program. **Priority - C.**

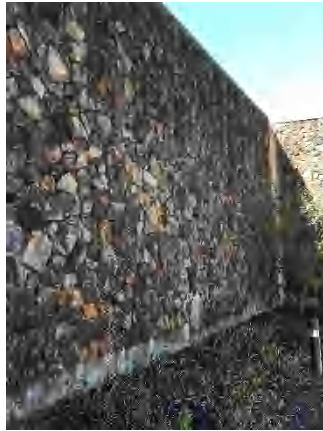
The exterior stone facade is in good condition. There were a few areas noted on the building where a stone piece was missing or was loose. The top of the stone façade is topped with a limestone cap on short parapet walls. The stone façade is merely the exterior surface material of the wall assembly. It is not a structural component of the building. Some minor tuckpointing is necessary as part of ongoing normal building maintenance. Other than areas of minor maintenance, whole building tuckpointing should not be anticipated for at least ten years.

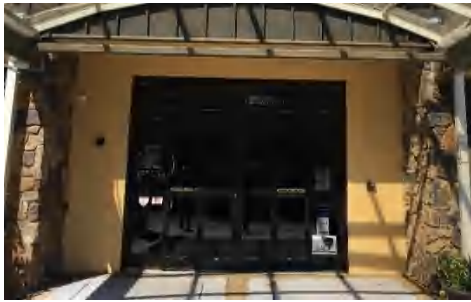
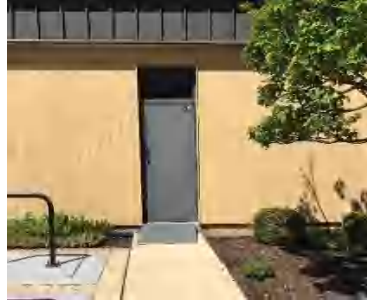
The service doors are hollow metal doors and frames. These doors are in fair to good condition and are consistent with their age and wear and tear cycle. Maintenance of exterior doors should include periodic painting every 3-5 years. The door leading from the Program Room was difficult to operate and does not seat well into the opening. This door is rated as Marginal and is recommended for replacement within two years.

- It is recommended that the exterior doors be serviced to ensure proper fit and operation, with the exterior door to the Program Room being recommended for replacement in two years. **Priority - A.**
- It is recommended that windows that are in disrepair be planned for replacement. There are approximately six windows that need replacement on the second floor. **Priority - A.**
- The remaining windows can be maintained in place and should be serviceable for 10+ years. Note that replacement of original windows with more energy efficient modern units will result in improved energy efficiency. **Priority - C.**

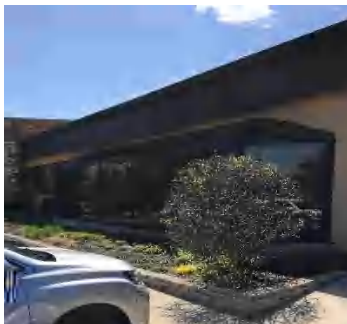
There are two main types of windows throughout the building. One main type is the atrium window in the adult reading area. This atrium window is an aluminum window unit with sloped glazing at the top that creates the atrium affect. The assembly is in good condition. The second main type are the wood casement windows with integral blinds. These units comprise the balance of the windows on the first and second floors. Many of these windows are original to their respective building wing age, although several windows on the first-floor north face of the building in the computer area and Technical Services were replaced in 2013. The remaining original windows are in fair to good condition. The integral blinds are in various stages of operation and a handful of windows have deteriorated seals and interior finishes. These deteriorated windows are in need of repair/replacement.

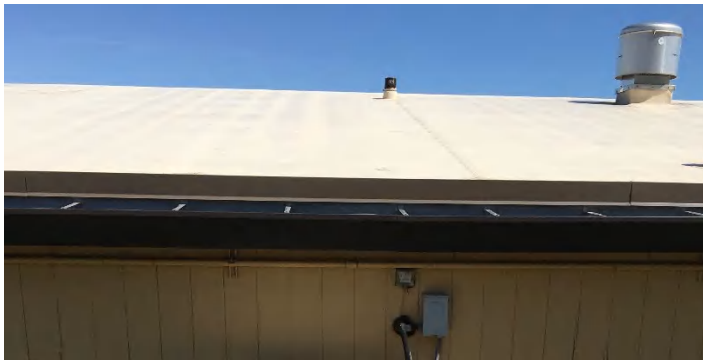
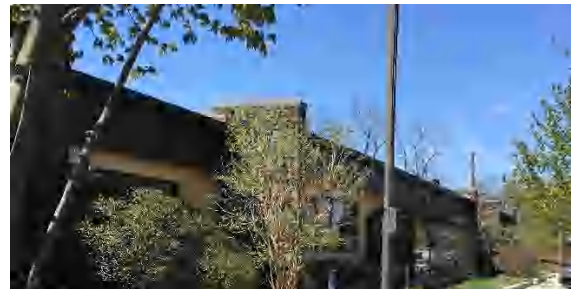
The roof of the west storage room addition was replaced in 2017. This roof had been leaking and was in need of replacement. It was noted during the assessment that the metal roof deck of the storage room is corroded and rusting. Future roof replacement may require replacement of sections of the metal deck.

**Recommendation:** Plan for replacement of roof system in 10-15 years. Note – Replacement of the roof will provide the opportunity to increase insulation value and increase energy efficiency of the building envelope. **Priority - C.**

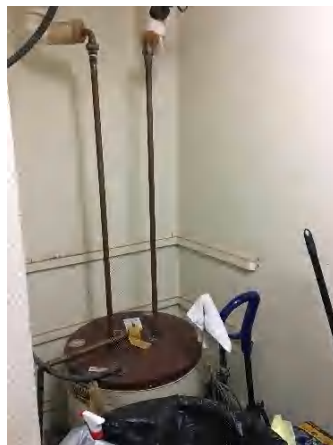
A small domestic water heater serves the main public restrooms on the intermediate level. This unit was apparently installed in 1996. This unit is beyond its useful life and should be scheduled for replacement within the next fiscal year.

Replace the domestic water heater in the janitor's closet serving the public restrooms on the Intermediate Level.  
**Priority – A.**

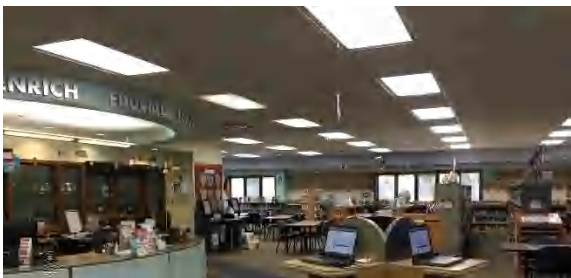
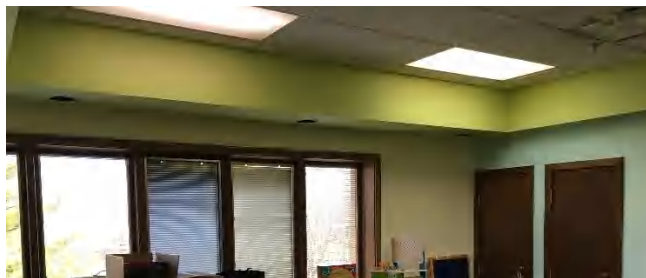
It was reported that the LED lamp replacement is being met with limited success. The pendant style light fixtures on the first floor are able to accept the LED lamps and function well. The older lay-in fixtures apparently do not contain the componentry to accommodate the newer LED lamps.

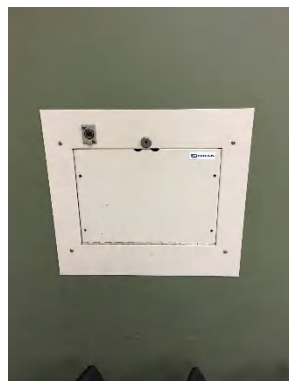
There is a paging system in the building with speakers located in limited areas, that is reported to be marginally effective, if at all. The paging system provides a mission critical function to staff for announcements and in the event of emergencies. The staff has expressed concerns over the quality of the system and the ability of the system to provide coverage in the building. The system was manufactured by Bogen and is near the end of its serviceable life.
