LISLE LIBRARY DISTRICT SPECIAL BOARD MEETING July 10, 2019 - 6:00 p.m.

- 1. Roll call
- 2. Opportunity for visitors to speak
- 3. Facility Condition Assessment Report/FQC | Discussion
- 4. Adjourn

Section 1 - Introduction

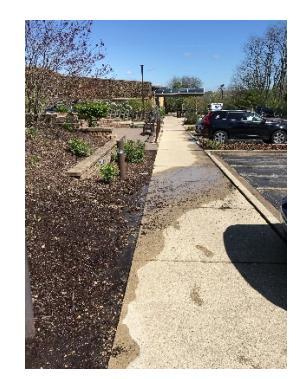
<u>Landscape mulch bed on west side of southeast parking lot:</u> During winter snow melt times and heavy spring rains, this sloped mulch bed seeps water across the sidewalk and into the parking lot. This was noted as an erosion concern and a safety concern during freeze/thaw cycles.

- Include all site drainage and stormwater issues as part of further investigation as presented in the Appendix. Improve drainage of landscape beds by updating or replacing drain tile system and installing a French drain assembly. Priority - Critical
- Perform maintenance to masonry planters and retaining walls that are in Fair condition and exhibiting signs of movement. **Priority B**

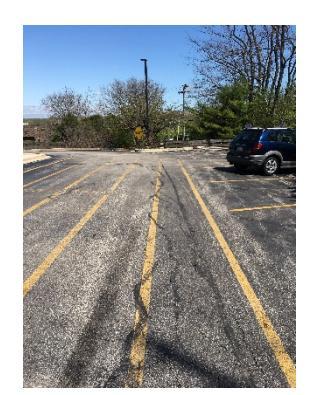
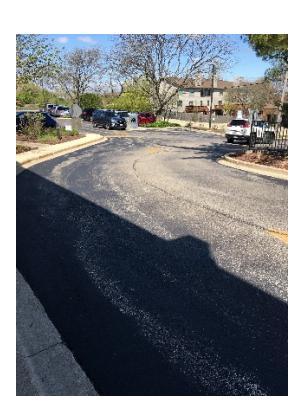
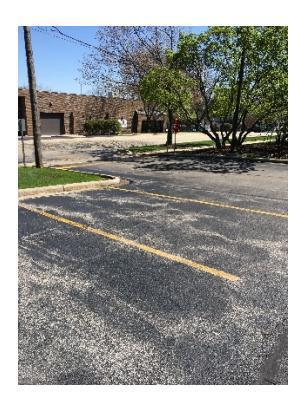
The parking lot is generally in good to fair condition. There are signs of age, including cracking of the surface layer and settlement in some isolated areas around tire spots in stalls and adjacent to storm structures in the parking lot. It appears that sealcoating and striping maintenance occurs periodically, having recently been recoated. With continued treatment of cracks and annual sealcoating, the parking lot will provide up to ten years of service.

- Perform annual maintenance and sealcoating/striping of parking lot. Priority A
- Repair cracked broken curbs. Budget for spot repairs of settled areas for short-term (0-2 year) repair. **Priority - Critical.**
- Budget for repaving entire lot in ten years. Priority C.

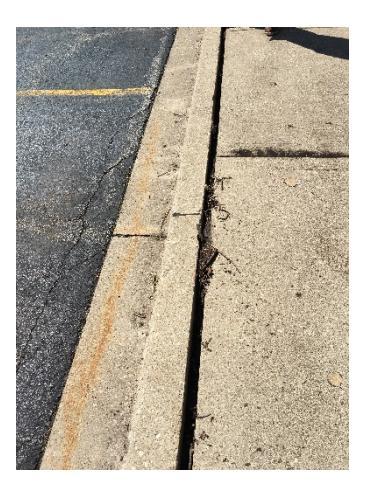
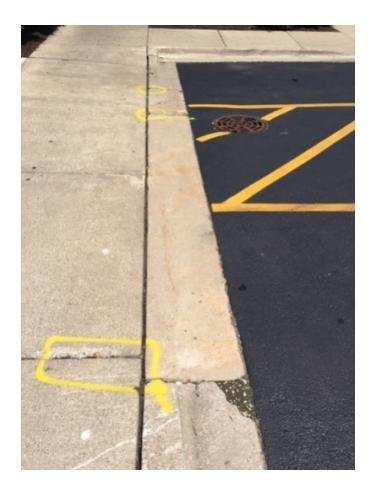
An area of concern with the sidewalk network is the type of original construction as it relates to the parking lot curbs. The concern is that the sidewalks and curbs are settling at different rates and separating from each other, in some instances by an inch or more. This condition creates a tripping hazard and the potential for a pedestrian's shoe to get stuck in the separation gap. The curbs and sidewalks were apparently poured as two separate pieces of concrete. When this occurs, rebar reinforcing is sometimes installed to connect the sidewalks and the curbs, although this type of installation is subject to cracking and other problems. No rebar was observed in the gaps. In more modern construction standards, sidewalk/curb installations are typically poured as an integral installation, with the curb and sidewalk as a monolithic unit. This installation type provides for a more integrated construction and was adopted as a direct result of the type of issues the Lisle Library sidewalk/curb installation is experiencing. Integral sidewalk curbs, due to their monolithic construction tend to settle more consistently and avoid the separation issue being experienced.

- The Library has been diligent about replacing broken or deteriorated sidewalks. This maintenance practice, as
 it relates to areas of concern both for curbs and sidewalks, is recommended to continue. Priority A for
 sidewalks as needed, Critical for curb deterioration.
- Long term (10+ years), the sidewalks could be replaced with integral curb and sidewalk installations as part of a wholesale parking lot replacement program. **Priority C.**

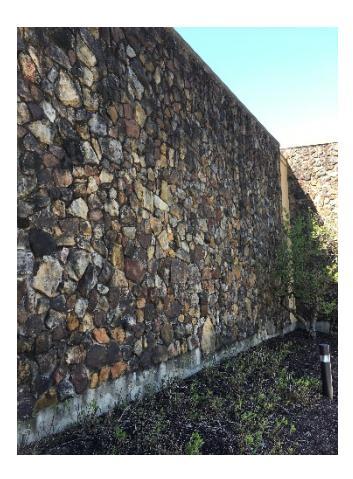
The exterior stone facade is in good condition. There were a few areas noted on the building where a stone piece was missing or was loose. The top of the stone façade is topped with a limestone cap on short parapet walls. The stone façade is merely the exterior surface material of the wall assembly. It is not a structural component of the building. Some minor tuckpointing is necessary as part of ongoing normal building maintenance. Other than areas of minor maintenance, whole building tuckpointing should not be anticipated for at least ten years.

- Perform minor maintenance tuckpointing. Priority B
- Budget for whole building tuckpointing. Priority C

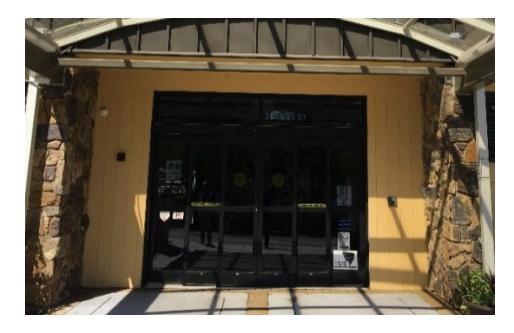
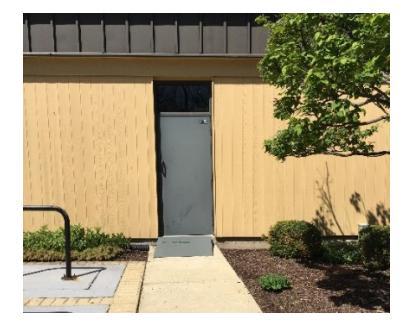
The service doors are hollow metal doors and frames. These doors are in fair to good condition and are consistent with their age and wear and tear cycle. Maintenance of exterior doors should include periodic painting every 3-5 years. The door leading from the Program Room was difficult to operate and does not seat well into the opening. This door is rated as Marginal and is recommended for replacement within two years.

- It is recommended that the exterior doors be serviced to ensure proper fit and operation, with the exterior door to the Program Room being recommended for replacement in two years. Priority - A.
- It is recommended that windows that are in disrepair be planned for replacement. There are approximately six windows that need replacement on the second floor. **Priority A.**
- The remaining windows can be maintained in place and should be serviceable for 10+ years. Note that replacement of original windows with more energy efficient modern units will result in improved energy efficiency. **Priority C.**

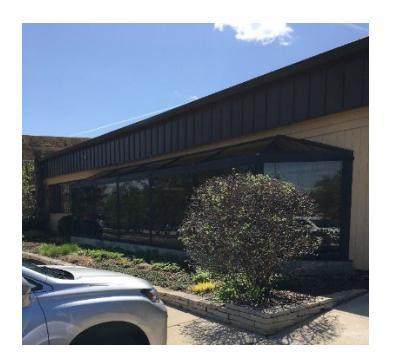
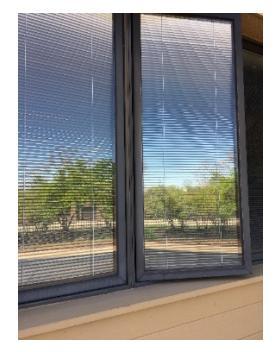
There are two main types of windows throughout the building. One main type is the atrium window in the adult reading area. This atrium window is an aluminum window unit with sloped glazing at the top that creates the atrium affect. The assembly is in good condition. The second main type are the wood casement windows with integral blinds. These units comprise the balance of the windows on the first and second floors. Many of these windows are original to their respective building wing age, although several windows on the first-floor north face of the building in the computer area and Technical Services were replaced in 2013. The remaining original windows are in fair to good condition. The integral blinds are in various stages of operation and a handful of windows have deteriorated seals and interior finishes. These deteriorated windows are in need of repair/replacement.

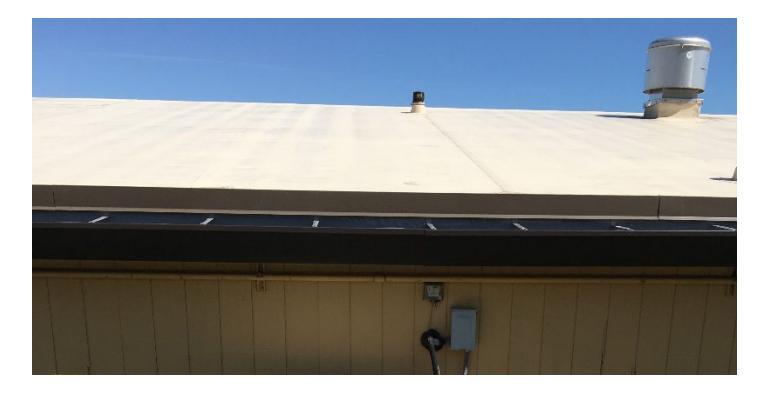
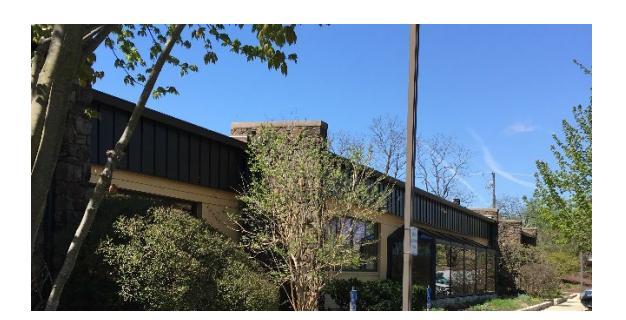
The roof of the west storage room addition was replaced in 2017. This roof had been leaking and was in need of replacement. It was noted during the assessment that the metal roof deck of the storage room is corroded and rusting. Future roof replacement may require replacement of sections of the metal deck.

As part of the design of the building, the roofing sheet metal creates a vertical standing seam metal panel detail at the top of the exterior walls. These metal panels are in good condition.

Recommendation: Plan for replacement of roof system in 10-15 years. Note – Replacement of the roof will provide the opportunity to increase insulation value and increase energy efficiency of the building envelope. **Priority - C.**

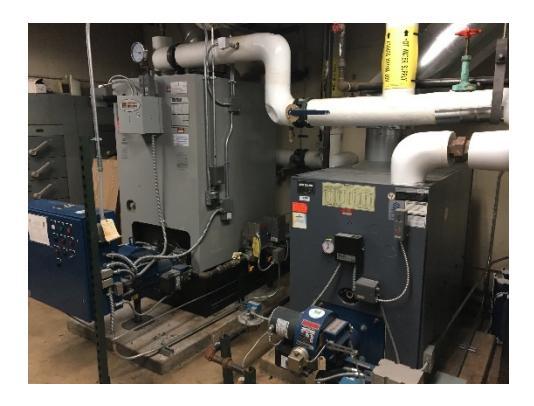
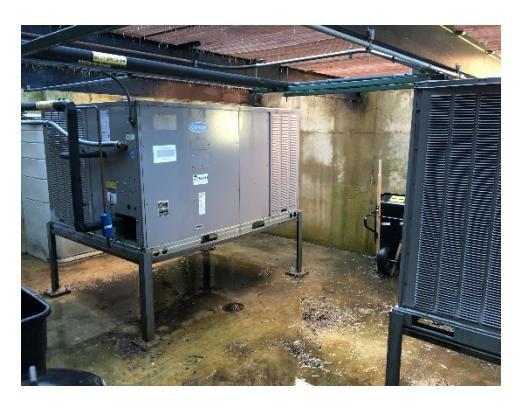
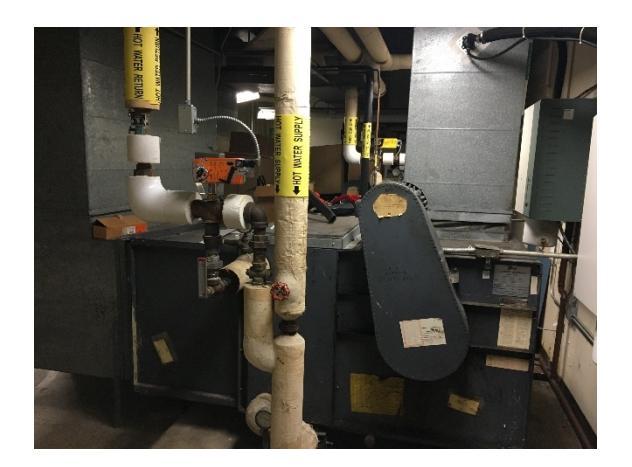
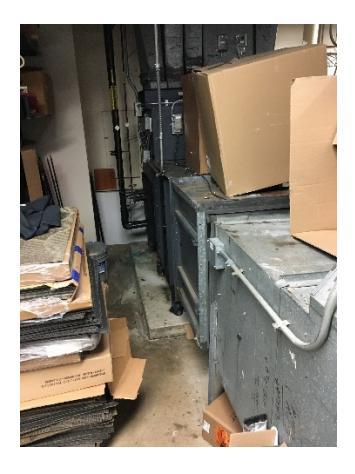
This area of the building is serviced by a Bryan hot water boiler HWB-1, located in the west mechanical room. This boiler provides hot water to various heating elements including cabinet unit heaters, convectors, etc. The age of the boiler could not be verified but is in the 5-8-year-old range based on model number. Distributed ventilated heating is provided by two Trane Air Handling Units (AHU-1W and AHU-2W), located in the west mechanical room. These units are approximately 37 years old. Cooling to the AHU's are supported via two Carrier condensing units, located in the west mechanical courtyard. These units are approximately 5 years old. There are also two Nortec humidifier units that are associated with each AHU. The system is controlled via a Precision Controls building automation system.

The system as it exists today provides sufficient heating, cooling and ventilation capacity. Due to changes in room usage in occupancy there are areas that are imbalanced and require adjustments or modifications to provide thermal comfort. The age of the Air Handling Units is the main concern as they are beyond their rated useful life of 30-35 years. They are of an age where parts are difficult to source, and the existing system is being maintained through the experience and familiarity of the system by Monaco. In the event of a complete failure of a system component, the main portion of the library could be without service for an extended period of time (4-8 weeks).

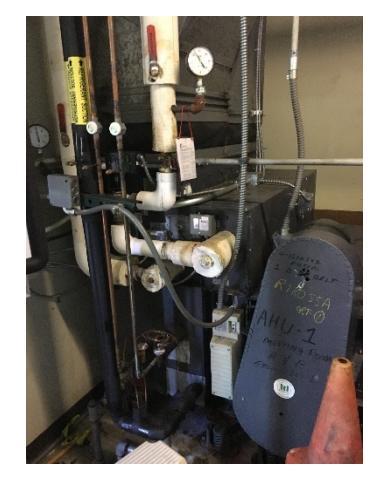
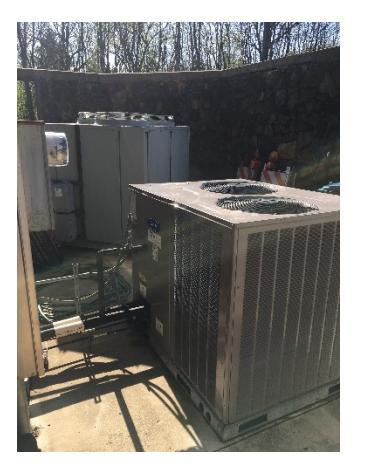
This area of the building is serviced by a Weil McLain hot water boiler HWB-E, located in the east mechanical room. This boiler provides hot water to various heating elements including cabinet unit heaters, convectors, etc. The boiler age is undetermined but is thought to be original from when the addition as constructed (30+ years). Distributed ventilated heating is provided by two Trane Air Handling Units (AHU-1E and AHU-2E), located in the west mechanical room. These units are approximately 30 years old. Cooling to the AHU's are supported via two condensing units (one Carrier – 5 years old and one Trane – 9 years old), located in the east mechanical courtyard. There is also one Carnes humidifier unit that serves these units. The system is controlled via a building automation system (Precision).

The system as it exists today provides sufficient heating, cooling and ventilation to the east addition portion of the building. The age of the Air Handling Units is the main concern as they are at their rated useful life of 30-35 years and experience frequent service calls. They are of an age where parts are difficult to source, and the existing system is being maintained through the experience and familiarity of the system by Monaco. In the event of a complete failure of a system component, the east portion of the library could be without service for an extended period of time (4-8 weeks). Additionally, the age and efficiency of the boiler indicate that a plan to replace the boiler would be consistent with good capital planning.

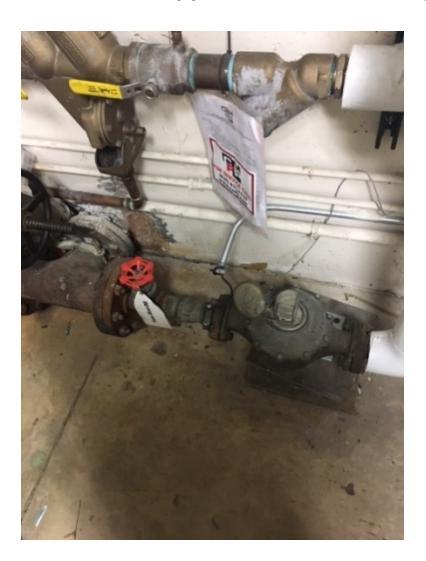
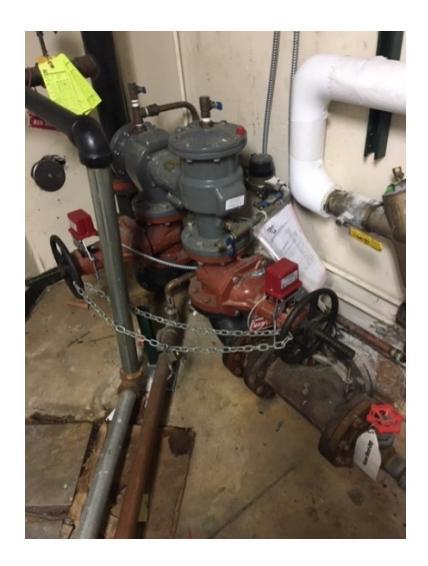
The 2-1/2" cold water service that enters the south side of the building is original to the 1980 building and is constructed of galvanized piping. The water service is equipped with a Village of Lisle water meter. Domestic water is distributed from the service with copper domestic water piping and also provides service to the sprinkler main.

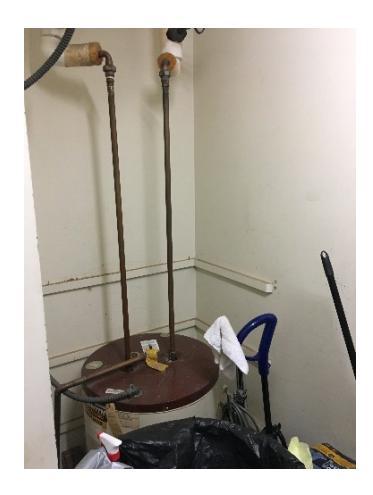
A small domestic water heater serves the main public restrooms on the intermediate level. This unit was apparently installed in 1996. This unit is beyond its useful life and should be scheduled for replacement within the next fiscal year.

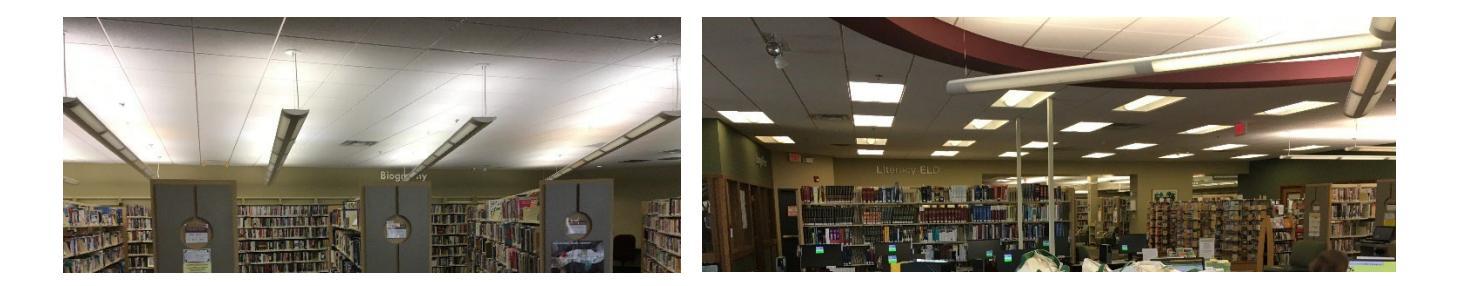
There are various types of fixtures inside the facility including pendant lights, 2'x2' lay-in, 2'x4' lay-in, troffers, round downlights, strip lights and decorative pendant lights. The Library has been on a program of updating fluorescent lamps with LED lamps within existing fixtures. We understand this program is continuing as some fixtures still contain fluorescent source with either T12 or pin-based compact fluorescent lamps. There are lights with incandescent lamps and some strip lights do still contain T12 lamps but they are isolated in the electrical/mechanical spaces.

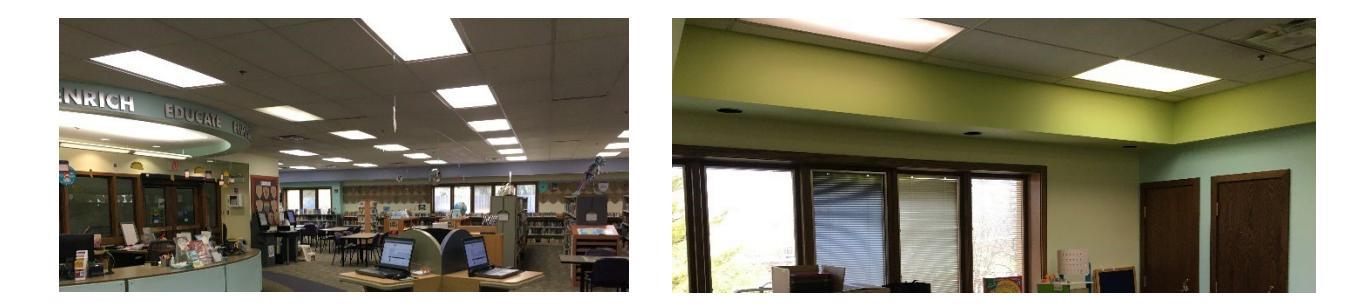
It was reported that the LED lamp replacement is being met with limited success. The pendant style light fixtures on the first floor are able to accept the LED lamps and function well. The older lay-in fixtures apparently do not contain the componentry to accommodate the newer LED lamps.

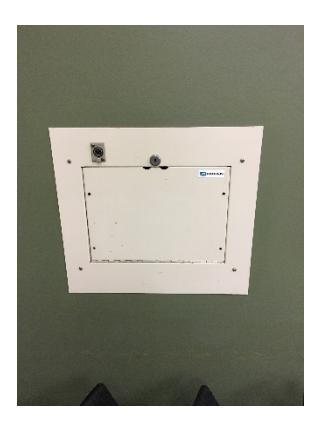
There is a paging system in the building with speakers located in limited areas, that is reported to be marginally effective, if at all. The paging system provides a mission critical function to staff for announcements and in the event of emergencies. The staff has expressed concerns over the quality of the system and the ability of the system to provide coverage in the building. The system was manufactured by Bogen and is near the end of its serviceable life.

The other Critical Priority item is the paging system. This system is in marginal condition at best and is a mission critical system for staff and patron safety. Upgrade/replacement of this system is recommended in the next year.
