# Lisle Library District

## Facility Condition Assessment Report

July 10, 2019

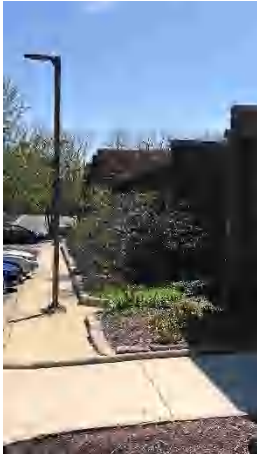
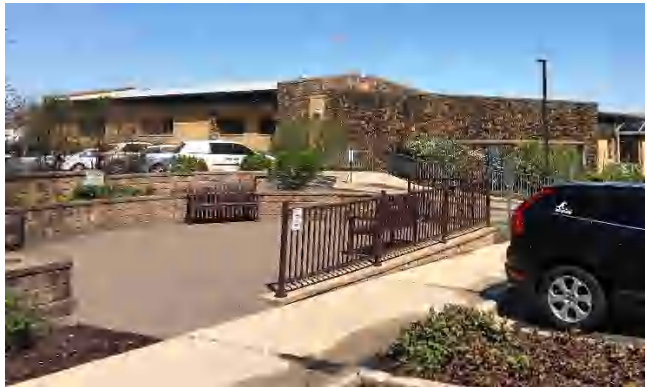
In several locations, the landscape features are integrated into or contribute to the site stormwater management system. One location is at the extreme southeast corner of the site, which has a stone retention feature that leads to a stormwater structure. The detention areas, while functional elements of the stormwater system, enhance the landscape environment of the site.

There are three locations of concern related to the landscape:

Far southeast corner off parking lot – stone retention feature at storm structure: This improvement was added to the site within the last couple of years and was intended to improve the erosion of that area from surface water flowing from neighboring residential properties to the south onto Library property. The stone feature has improved the erosion condition on Library property but the flow of water from neighboring properties carries with it sediment, leaves and debris that collect in the Library storm structure. This condition requires regular maintenance.

Landscape mulch bed on west side of southeast parking lot: During winter snow melt times and heavy spring rains, this sloped mulch bed seeps water across the sidewalk and into the parking lot. This was noted as an erosion concern and a safety concern during freeze/thaw cycles.

Landscape mulch bed on west side of north parking lot adjacent to Receiving Door: During winter snow melt times and heavy spring rains, this sloped mulch bed seeps water down the hill into the north parking lot and across the staff entry drive aisle. This was noted as an erosion concern and a safety concern during freeze/thaw cycles.

- Include all site drainage and stormwater issues as part of further investigation as presented in the Appendix. Improve drainage of landscape beds by updating or replacing drain tile system and installing a French drain assembly. **Priority - Critical**
- Perform maintenance to masonry planters and retaining walls that are in Fair condition and exhibiting signs of movement. **Priority - B**

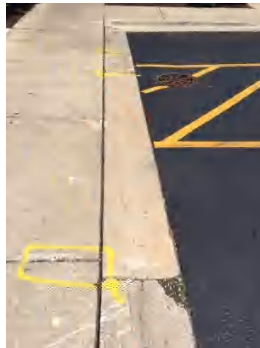
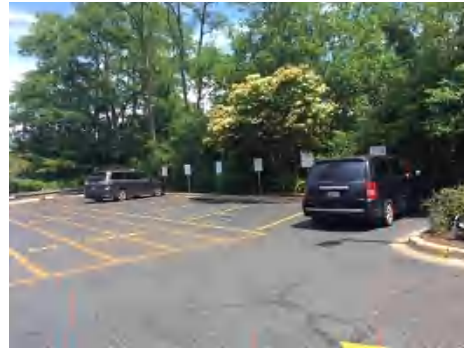
The parking lot is generally in good to fair condition. There are signs of age, including cracking of the surface layer and settlement in some isolated areas around tire spots in stalls and adjacent to storm structures in the parking lot. It appears that sealcoating and striping maintenance occurs periodically, having recently been recoated. With continued treatment of cracks and annual sealcoating, the parking lot will provide up to ten years of service.

- Perform annual maintenance and sealcoating/striping of parking lot. **Priority - A**
- Repair cracked broken curbs. Budget for spot repairs of settled areas for short-term (0-2 year) repair. **Priority - Critical.**
- Budget for repaving entire lot in ten years. **Priority - C.**

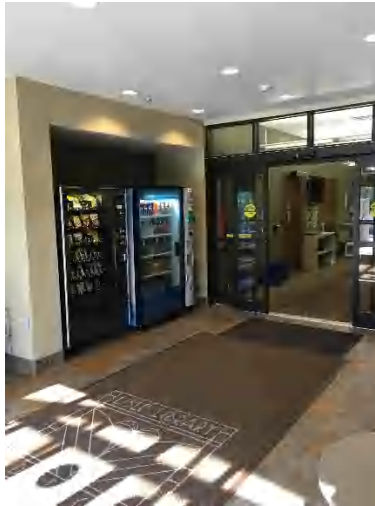
The finishes (flooring, wall paint, lighting) in the main lobby, vestibule, stair and elevator were updated in 2016 and appear to be consistent with the more recent updates on the First Floor. The public restrooms, other than possibly the flooring, appear to be original construction. While there may have been some updates such as automatic faucets, the finishes and general appearance of the restrooms are dated and would benefit from being updated.

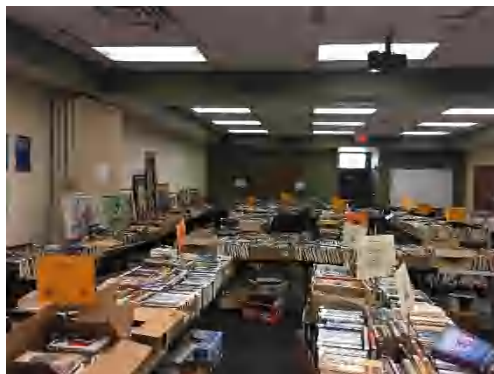
The Program Room consists of a large room, which can be subdivided into two rooms with an operable partition wall, storage closets and a small kitchenette. Other than the carpet, which was replaced in 2016, the finishes and general appearance of the Program Room is dated and would benefit from being updated.

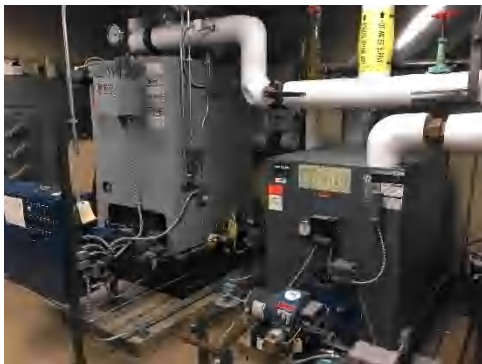
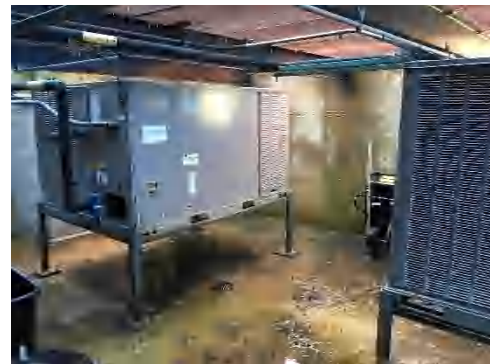
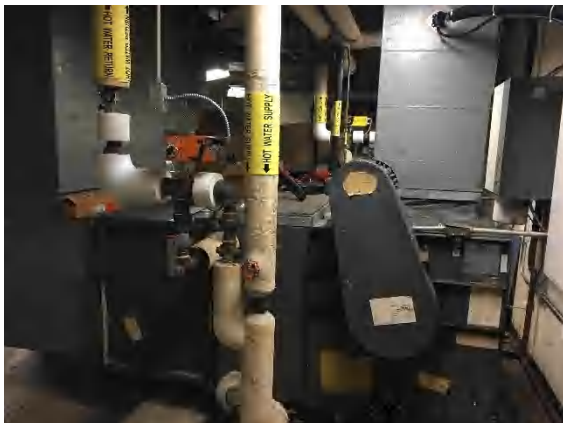
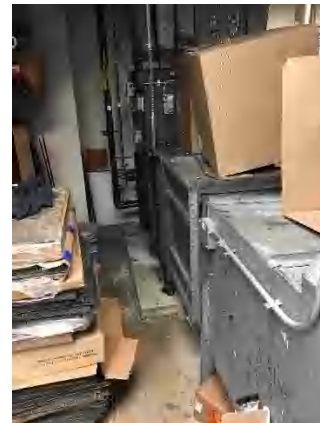
The system as it exists today provides sufficient heating, cooling and ventilation capacity. Due to changes in room usage in occupancy there are areas that are imbalanced and require adjustments or modifications to provide thermal comfort. The age of the Air Handling Units is the main concern as they are beyond their rated useful life of 30-35 years. They are of an age where parts are difficult to source, and the existing system is being maintained through the experience and familiarity of the system by Monaco. In the event of a complete failure of a system component, the main portion of the library could be without service for an extended period of time (4-8 weeks).

RTU-1: This unit apparently only serves the adult services office on the first floor and is approximately nine years old. It is not known why this unit was added to the Library, but it may have had something to do with the office being closed in and not being provided enough volume and capacity for thermal comfort and ventilation. RTU-1 has a useful life of 20 years, so other than operating costs, it should be able to be maintained with normal maintenance. As part of the replacement of the AHU's mentioned above, it may make sense to have this area re-engineered to determine if RTU-1 is still necessary.

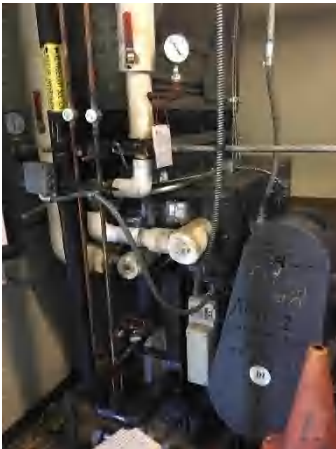
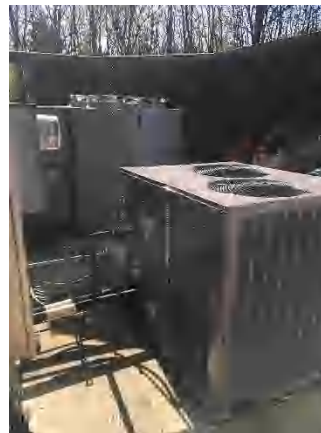
The system as it exists today provides sufficient heating, cooling and ventilation to the east addition portion of the building. The age of the Air Handling Units is the main concern as they are at their rated useful life of 30-35 years and experience frequent service calls. They are of an age where parts are difficult to source, and the existing system is being maintained through the experience and familiarity of the system by Monaco. In the event of a complete failure of a system component, the east portion of the library could be without service for an extended period of time (4-8 weeks). Additionally, the age and efficiency of the boiler indicate that a plan to replace the boiler would be consistent with good capital planning.

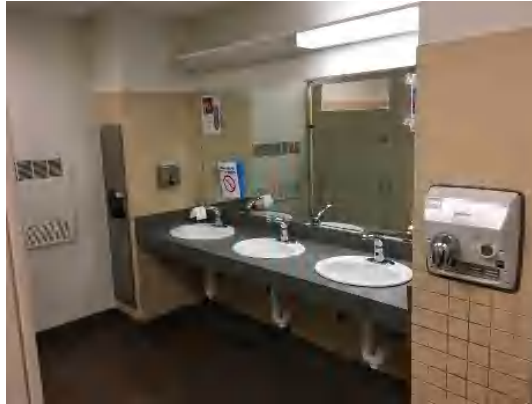
Sanitary drainage is mainly cast-iron piping. Piping is in good condition and waste flows well under normal conditions. Piping clogs have been noted in the original building and were serviced via rodding. Occasional blockages do occur when library patrons' flush improper items.

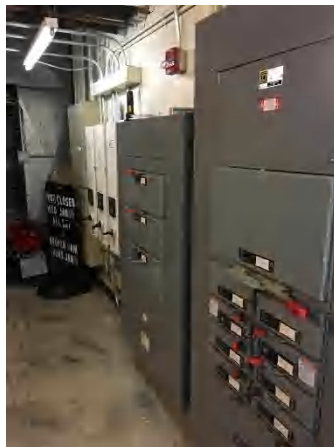
Lighting/receptacle panels contain circuit breakers and distribute power throughout the facility. Panels do contain some spaces for additional loads. Receptacles are provided throughout the building but with the increase in portable devices and the demand for additional power outlets, the location and quantity of receptacles is not ideal.

Access to power is not ideal. Floor boxes are not located next to current furniture configurations, or wall boxes are not conveniently located. The Library has resorted to installing power poles to provide staff and patron access to power where needed. Due to the need for lighting controls, updated light fixtures, concerns about power quality (surges), access to power, an inadequate paging system and replacing the UPS device, it would be recommended to work with an electrical engineer familiar with library operation and to perform an analysis of your electrical system needs going forward. Each of these items could be handled on a one-off basis as currently being attempted. However, the combination of lighting replacement, lighting controls and power needs would benefit the Library by taking a more comprehensive look at these issues together. **Priority – A (analysis only).**

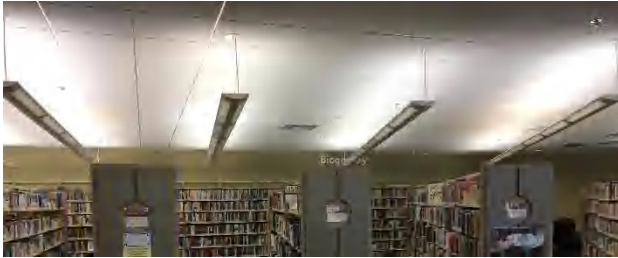
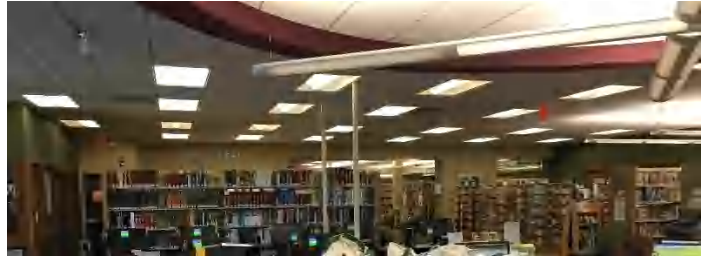
There are various types of fixtures inside the facility including pendant lights, 2'x2' lay-in, 2'x4' lay-in, troffers, round downlights, strip lights and decorative pendant lights. The Library has been on a program of updating fluorescent lamps with LED lamps within existing fixtures. We understand this program is continuing as some fixtures still contain fluorescent source with either T12 or pin-based compact fluorescent lamps. There are lights with incandescent lamps and some strip lights do still contain T12 lamps but they are isolated in the electrical/mechanical spaces.

It was reported that the LED lamp replacement is being met with limited success. The pendant style light fixtures on the first floor are able to accept the LED lamps and function well. The older lay-in fixtures apparently do not contain the componentry to accommodate the newer LED lamps.

T12 fluorescent lighting still exists throughout various areas of the building, while some has been replaced with LED lamps. The LED replacement program should continue but will likely need to incorporate replacement of older fixtures (Note: There are grant programs that help offset some costs associated with lighting replacement projects). **Priority - A.**

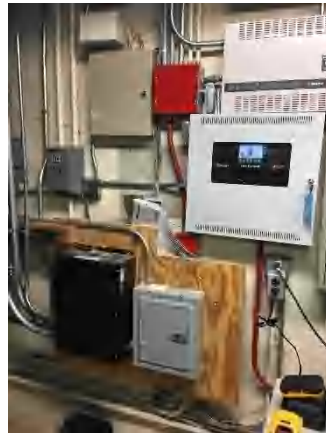
The building is protected throughout with smoke/heat detectors and audio/visual notification devices that are tied to a control panel located in the First-Floor mechanical room. The fire alarm control panel was manufactured by Simplex (4007ES) and it is an addressable system. The system was recently updated (January, 2019) is in good condition and the devices appear to be adequately installed throughout the building.

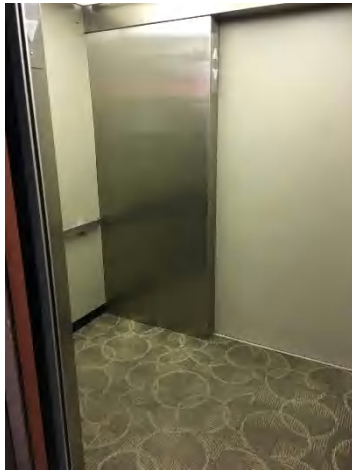
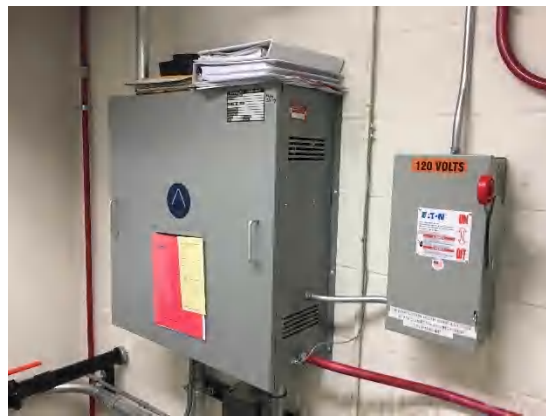
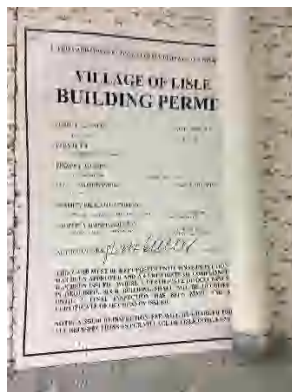
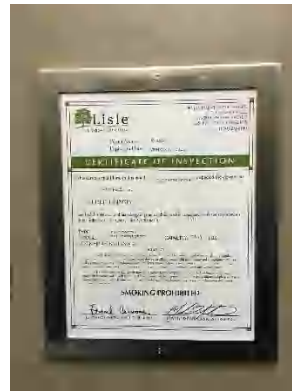
The building is served by a double-sided three stop elevator. The elevator was recently modernized in 2018 by Colley Elevator and is current with all inspections. Due to the recent modernization work this elevator will continue to serve the intended purpose for 10-20 years with proper maintenance and inspections. **Priority – No Rating Required.**
