LISLE LIBRARY DISTRICT SPECIAL BOARD MEETING July 10, 2019 - 6:00 p.m.

- 1. Roll call
- 2. Opportunity for visitors to speak
- 3. Facility Condition Assessment Report/FQC | Discussion
- 4. Adjourn

Section 1 - Introduction

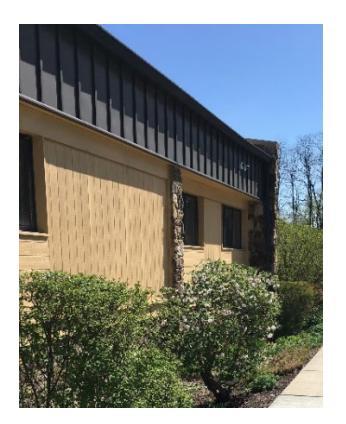
The exterior of the building is a combination of the stone façade mentioned above and wood siding. The wood siding is painted and in good condition. There were no obvious signs of deterioration. As a painted surface, the siding will need to be part of regular ongoing facility maintenance planning.

• Perform periodic building painting. Priority - B.

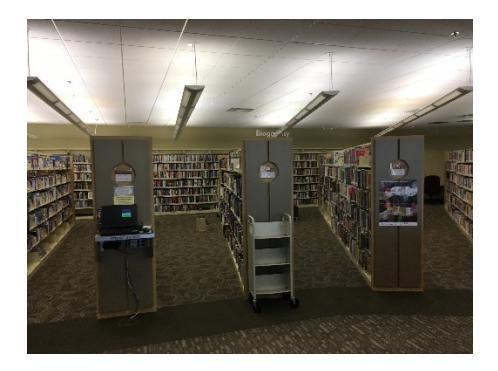
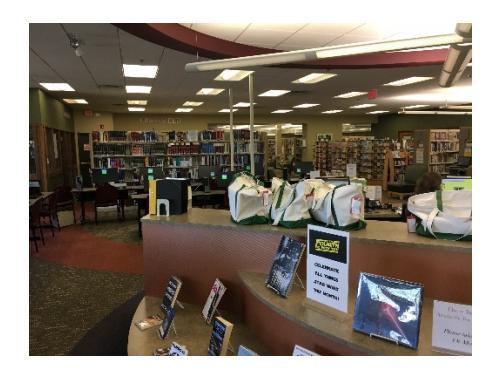
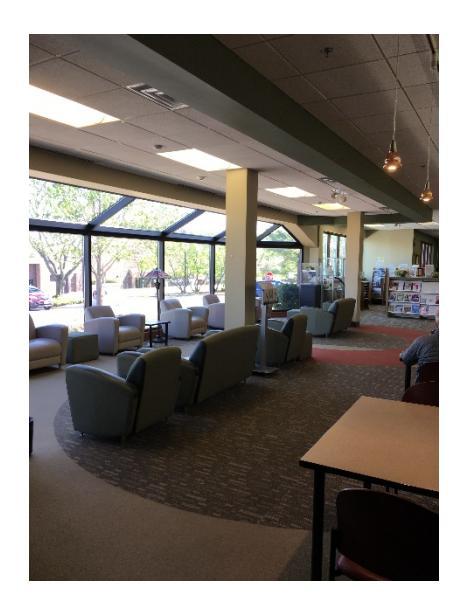
The first floor previously went through a renovation in 2007 and, other than typical wear and tear (especially to carpet) is in good condition. The carpet is showing signs of wear and will need to be replaced as part of a normal maintenance/upgrade cycle (typically every 8-10 years). Much of the carpet is broadloom versus carpet squares, which is a factor in maintenance and replacement. No recommendation is provided for the public spaces except for normal maintenance. Comprehensive updates to staff areas and offices appear to have been deferred in favor of public spaces. Staff areas are in Fair condition.

- The interior finishes of the building are more closely tied to programmatic and functional needs and desires than facility assessment characteristics. Carpet is an ongoing maintenance item in modern libraries and is due for replacement in many areas. **Priority A.**
- In terms of investment dollars, it is recommended that higher cost areas, such as the restrooms, receive planned updates to avoid deterioration to a point where replacement or upgrades are required out of dire necessity rather than as part of an intentional planned approach. **Priority B.**
- Forward looking capital planning for replacement of finishes such as flooring, painting, ceiling tiles, etc. are recommended. **Priority B.**

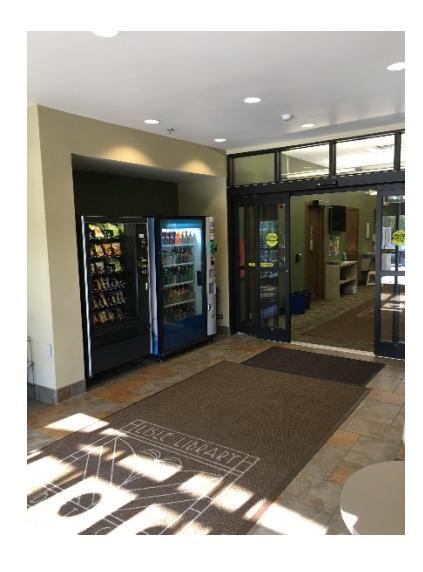
The finishes (flooring, wall paint, lighting) in the main lobby, vestibule, stair and elevator were updated in 2016 and appear to be consistent with the more recent updates on the First Floor. The public restrooms, other than possibly the flooring, appear to be original construction. While there may have been some updates such as automatic faucets, the finishes and general appearance of the restrooms are dated and would benefit from being updated.

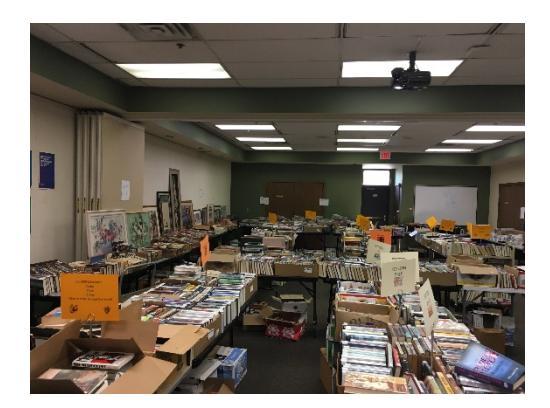
The Program Room consists of a large room, which can be subdivided into two rooms with an operable partition wall, storage closets and a small kitchenette. Other than the carpet, which was replaced in 2016, the finishes and general appearance of the Program Room is dated and would benefit from being updated.

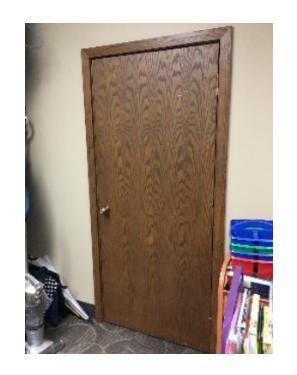
Casework/Interior Doors: Much of the building appears to still retain original casework, countertops and interior doors. These components are in fair condition and appear serviceable. At the same time these components are aging to the point where replacement parts, hardware and repair may prove costly. Additionally, some door hardware would benefit from being updated. In the event the Library would undergo future renovation, replacement and upgrade of these items in conjunction with a larger project would be recommended.

• Establish a door hardware replacement program. Priority B.

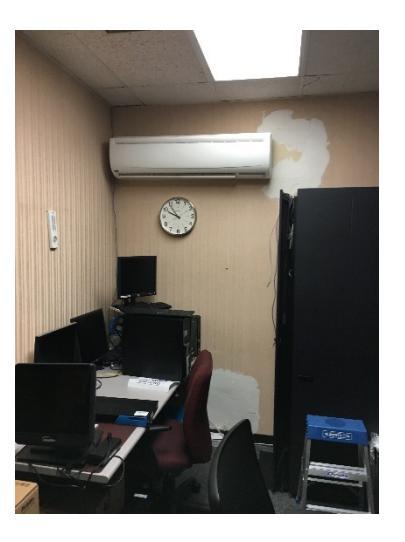
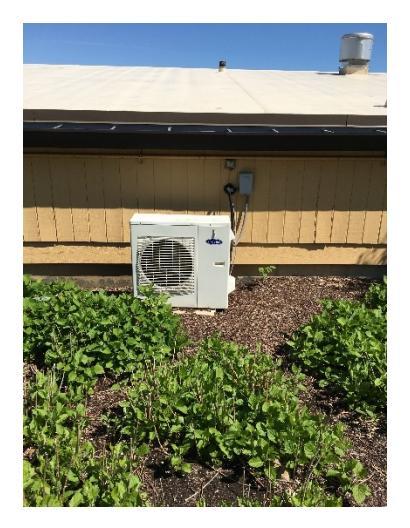
The server room is cooled by a Carrier Split System that has a fan coil unit inside the room and an air-cooled condensing unit located outside the south wall of the building adjacent to the server room.

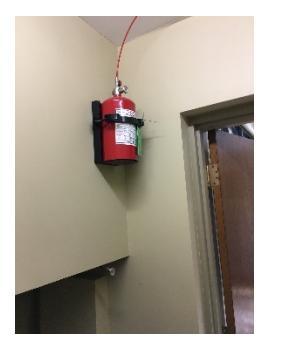
The book drop room adjacent to the main entry is served by a dedicated fire control system. This is consistent with good practices for this room type.

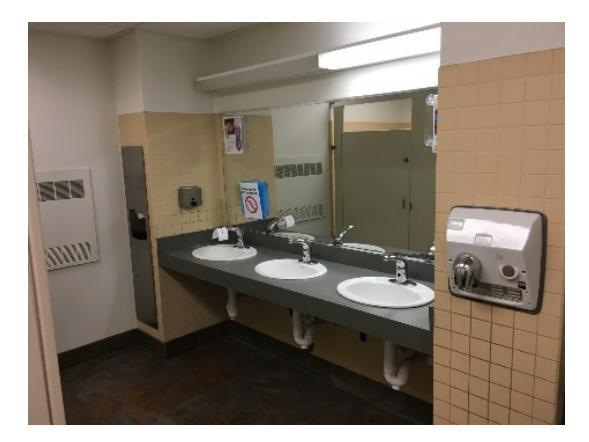
Toilet room plumbing fixtures are a variety of standard fixtures. Domestic water supply piping to these fixtures are copper. Water closets and urinals are wall hung and floor mounted china fixtures with sensor-activated battery-powered flush valves. Lavatories are individual china bowls integral with laminate counter and have sensor activated battery-powered faucets. The battery-operated function is subject to outages due to battery life. The fixtures are all in good condition.

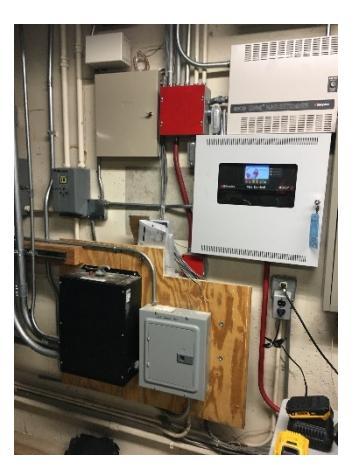
The building is protected throughout with smoke/heat detectors and audio/visual notification devices that are tied to a control panel located in the First-Floor mechanical room. The fire alarm control panel was manufactured by Simplex (4007ES) and it is an addressable system. The system was recently updated (January, 2019) is in good condition and the devices appear to be adequately installed throughout the building.

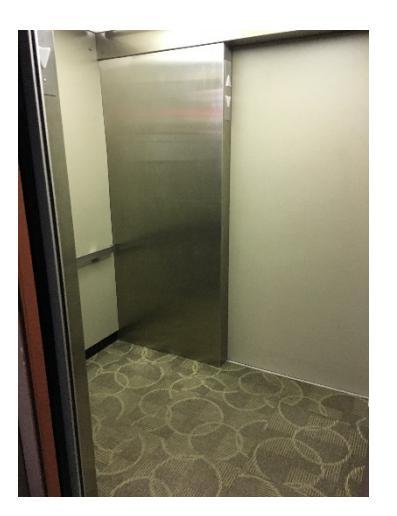
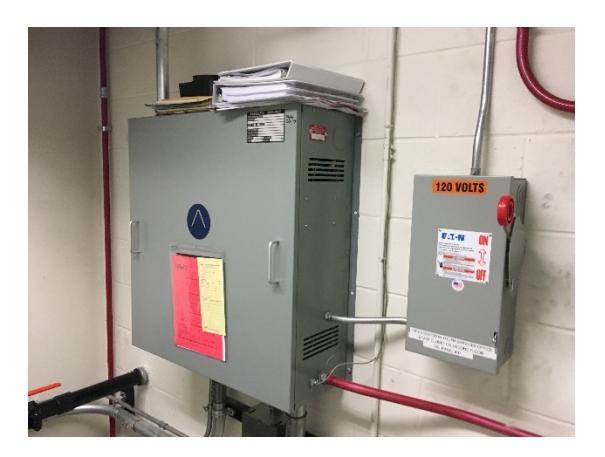
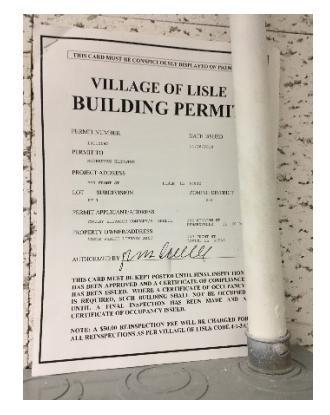
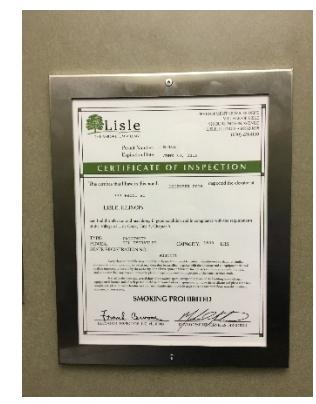
The building is served by a double-sided three stop elevator. The elevator was recently modernized in 2018 by Colley Elevator and is current with all inspections. Due to the recent modernization work this elevator will continue to serve the intended purpose for 10-20 years with proper maintenance and inspections. **Priority – No Rating Required.**
